Avalanche Details: [Shooting Cracks at Bridger Bowl](#)

Bridger Range, 2019-10-31

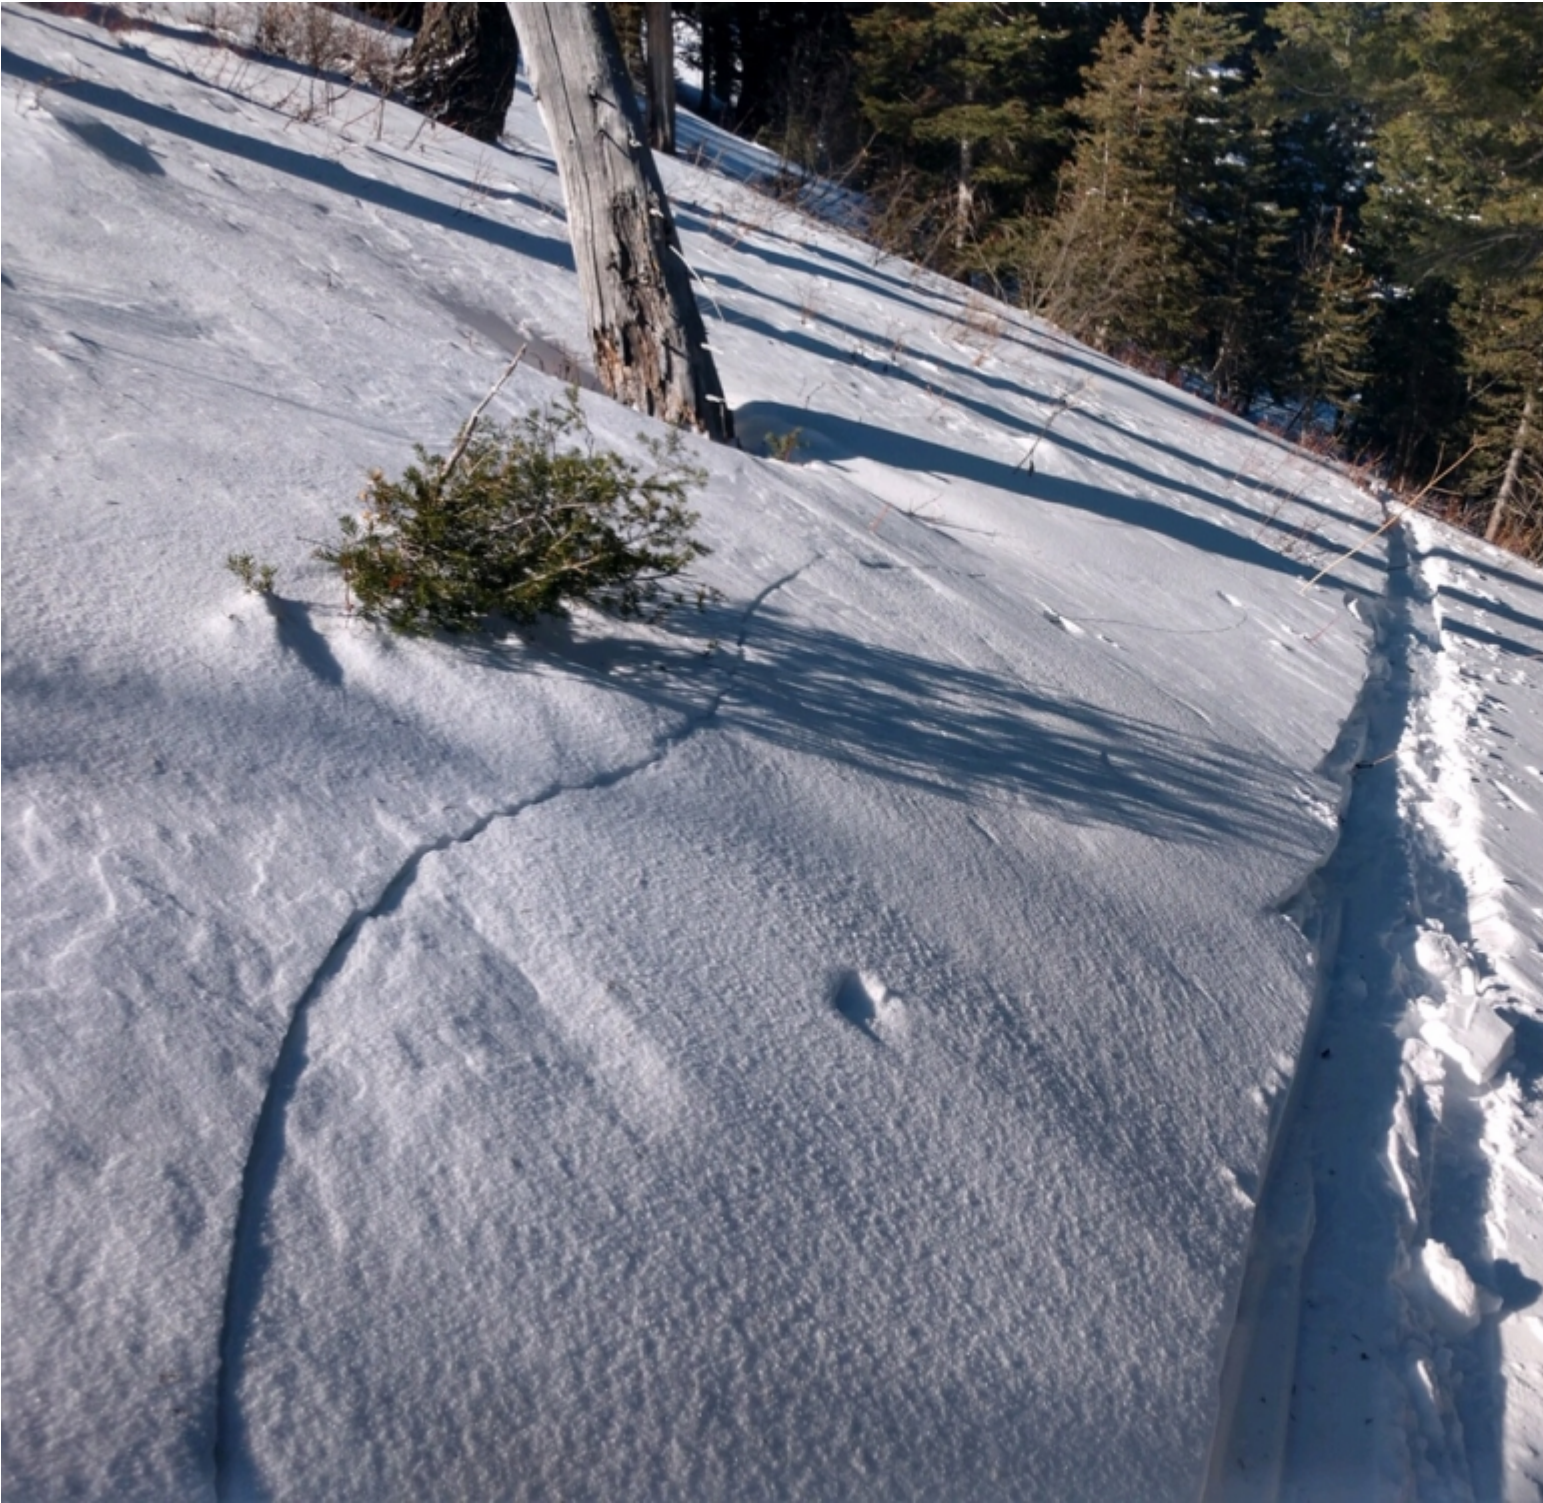
From an email, "...here's a pic from a north facing slope below Thunder Road, about midway up PK. We saw a few more shooting cracks in the flats below the top of PK, and the surface wind slab where this photo was taken was ~10 cm."
